Weston Solutions, Inc.  
20 North Wacker Drive, Suite 1210  
Chicago, IL 60606  
Phone: 312-424-3300 • Fax: 312-424-3330  
[www.westonsolutions.com](http://www.westonsolutions.com)

17 March 2004

Re: Point source emissions assessment during fluorescent bulb recycling

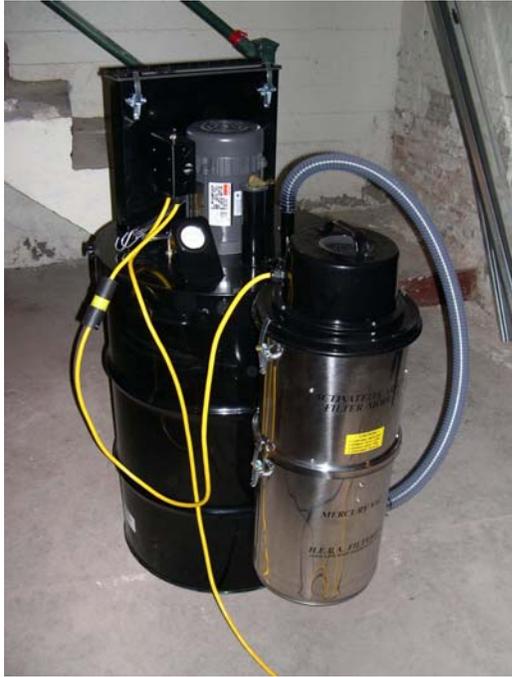
Photograph No. 1. The Mercury Vapor Vac and Bulb Compactor at the testing location. The filter unit is in the foreground with the crushing unit on top of the 55-gallon drum. The large box-like structure is the entrance for the addition of circline bulbs. Linear bulbs are added through the circular port located in front of the mounted motor.

The Bulb Compactor (see Photograph No. 1) consists of three main components: the crushing unit, the mercury vapor filter unit, and the waste collection drum. The crushing unit mounts directly onto the waste collection drum. A rubber gasket forms a seal around the drum and the crushing unit; thus, the crushing unit itself acts as a drum lid. A motor mounted on the top of the unit is connected to the shaft, onto which a blade (located inside the drum) is attached. Bulbs are then crushed as they are fed into the unit.

Bulbs can be added to two openings. A circular opening (approximately 2.5 inches in diameter) allows standard 2-foot, 4-foot, and 8-foot linear fluorescent bulbs to be added. Attachments (consisting of hollow metal tubes) fit over this opening and allow the bulbs to be safely fed into the machine. A second rectangular opening is approximately 2 inches by 14 inches and is raised about 14 inches above the lid (thus appearing as a metal box on top of the unit). This allows for

the addition of circline (and U-shape) fluorescent bulbs. Both of the bulb openings are sealed when not in use.

The filter unit is attached to the drum and crushing unit and is physically supported at the top of the crushing unit by a metal bracket. A 2-inch plastic accordion vacuum hose runs from the top of the crushing unit to the bottom of the filter unit. The filter unit is an off-the-shelf mercury vapor vacuum consisting of a motor attached to a canister, which contains a series of filters. When the motor is turned on, a vacuum is created, and air is drawn from the 55-gallon drum through the hose and into the filter unit. Air is expelled out the top of the filter unit after it has passed through the series of filters. A pressure gauge at the top of the crushing unit measures the extent of the vacuum created in the drum.

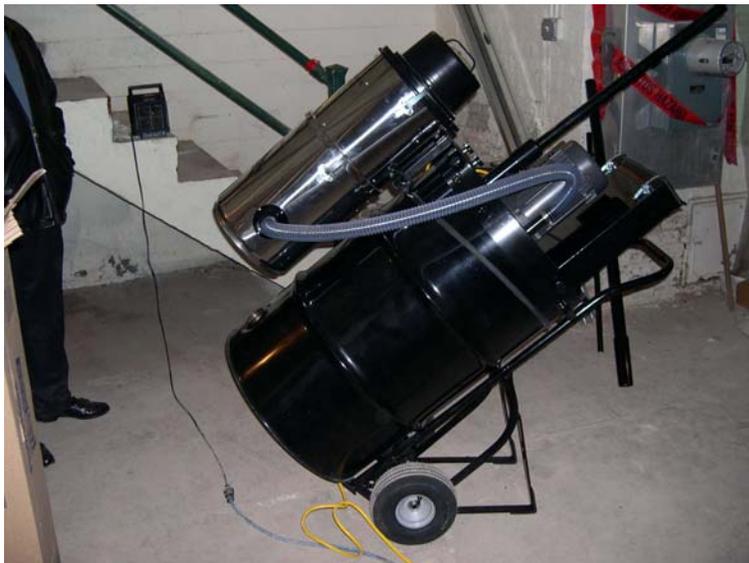
Photograph No. 2. The Mercury Vapor Vac and Bulb Compactor in its working position for the addition of long linear bulbs. Note the attached tube on the linear bulb entrance.

The entire Bulb Compactor can be placed at a 45 degree angle to allow long linear tubes to be fed into the machine. This was the position used throughout this test (see Photograph No. 2).
